THE RESTORATION OF THE KRISHNA TEMPLE

PATAN - NEPAL

2015 - 2018

NEETA DAS

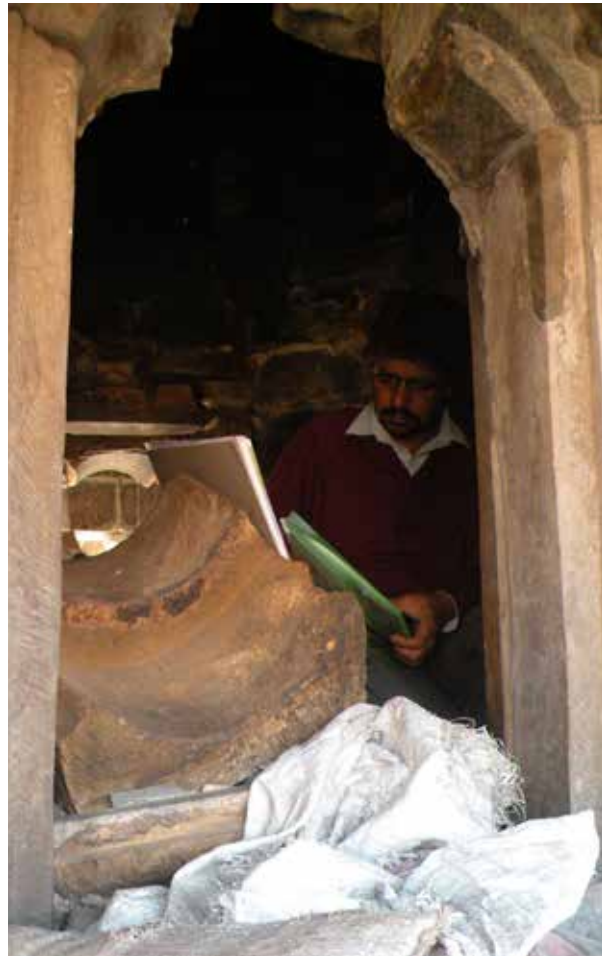
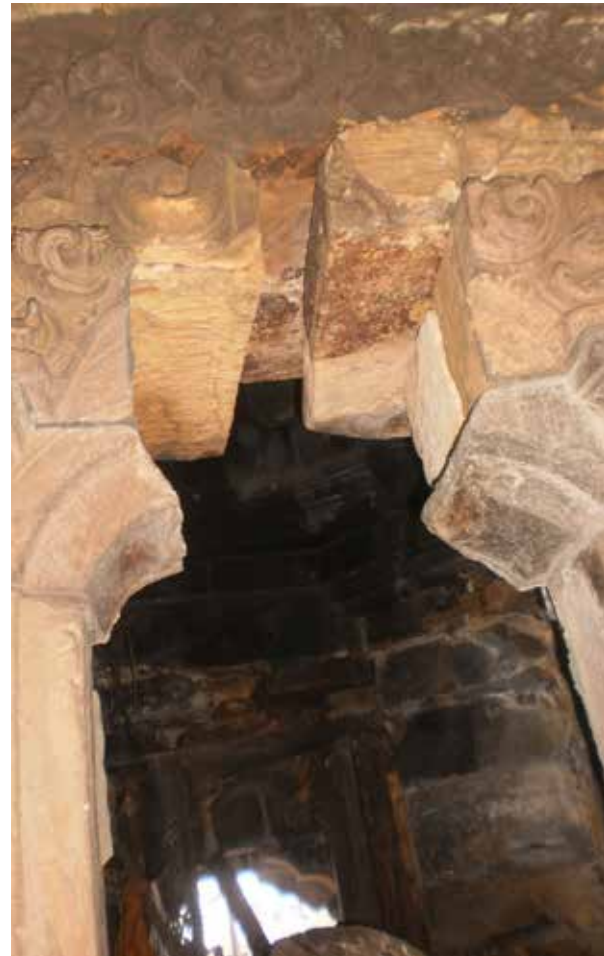
Dislocated key stones and door jambs

Center & Right
Fallen keystone on the North face
of the *garbha griha*.

The *garbha griha* has four openings, one on each side. Three of these are windows with stone *jaalis*, or screens. The opening on the north side has a metal door, with a similar design as the window screens. Due to the movement of the corners, the key stones of the door and window openings had been dislocated or fallen down. But luckily all the key stones, which are made

It was recommended that all the pieces be collected, marked, and stored in a safe place. The safest place found was the *garbha griha* where all the broken stones were kept. The next step was to brace and support all the openings to prevent further damage. These braces were of wood to protect the carved stones from chipping. After the corners were repaired, the openings were

supported and the stones pieces slowly removed and placed in position. This was done from both the inside and outside of the opening. The joints were stainless steel pins, compatible mortar as per specifications, and a strong stone adhesive, as and where needed. The metal door was cleaned, repaired, and replaced in position. As were the stone window *jaalis*.

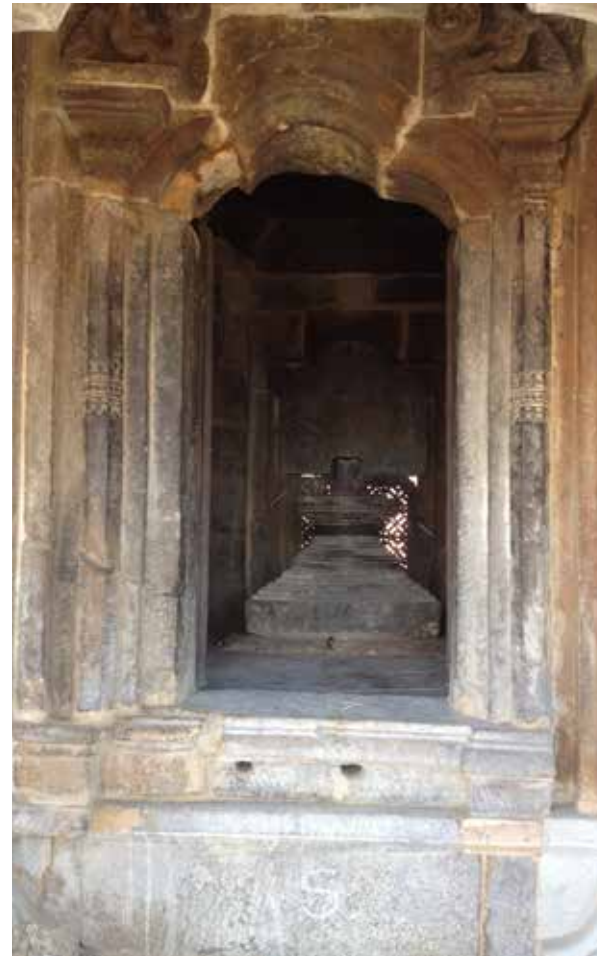
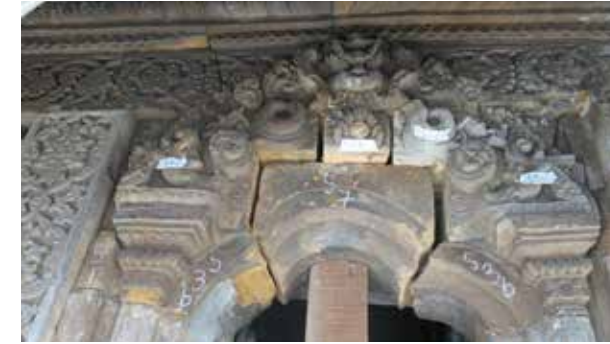
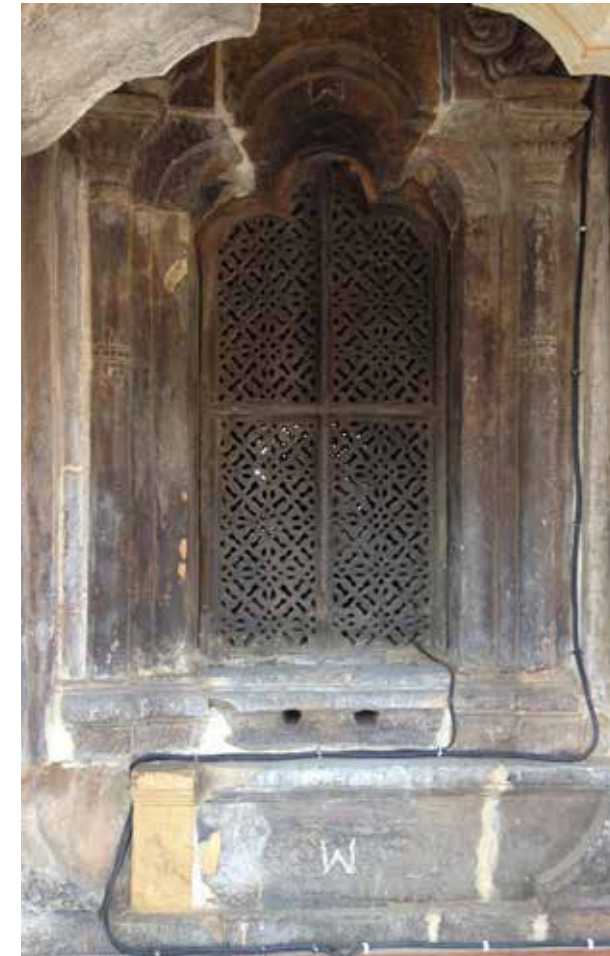
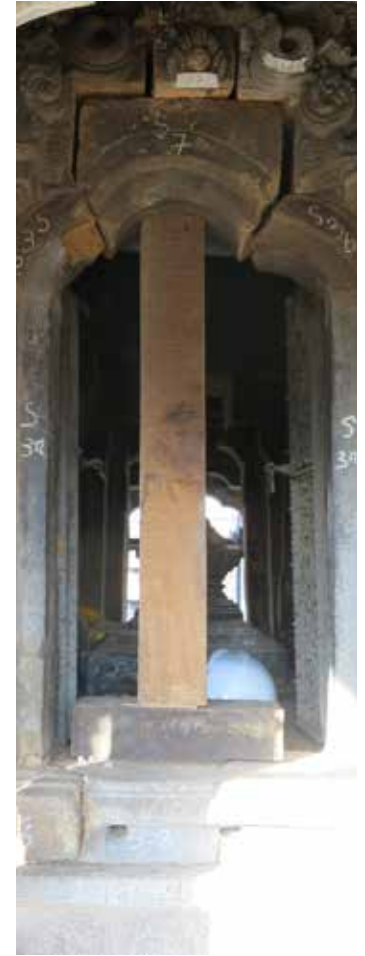
Left
Keystone on the South face of
the *garbha griha* and the *linga*
restored.

Center Bottom
Restored West face of the *garbha*
griha.

Center Top & Right
Dislocated keystones on the
openings of the *garbha griha*.

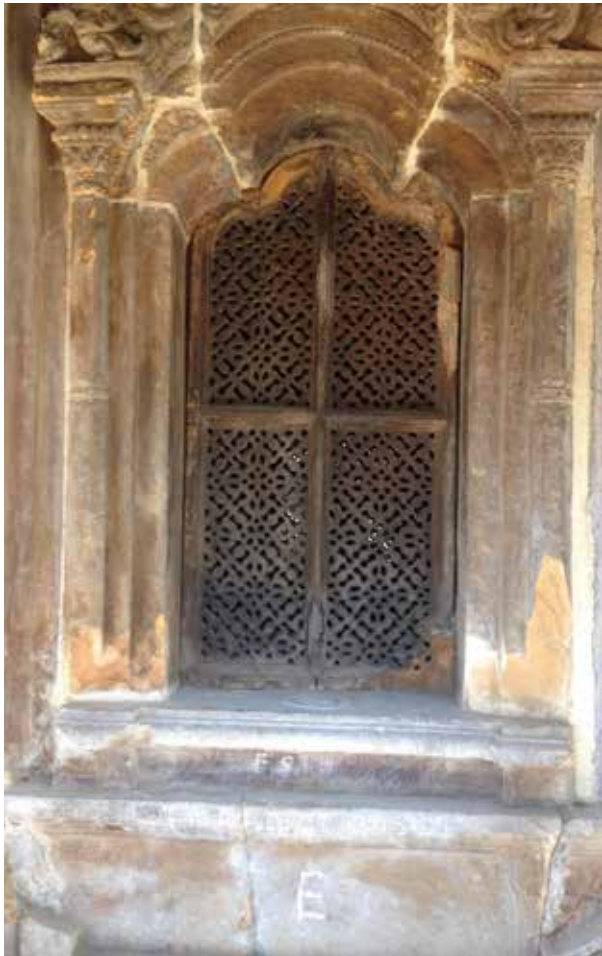
Left Top
Restored opening on the east face of the *garbha griha*.

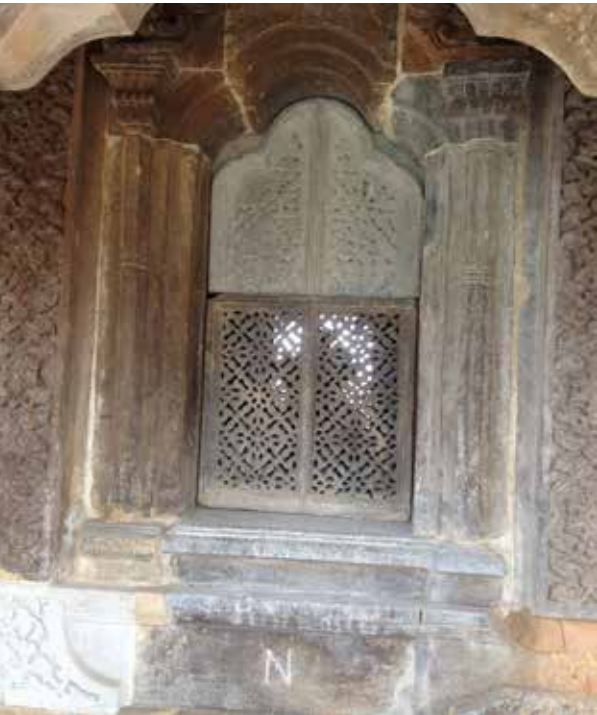
Right Top
Restored opening on the north side of *garbha griha*.

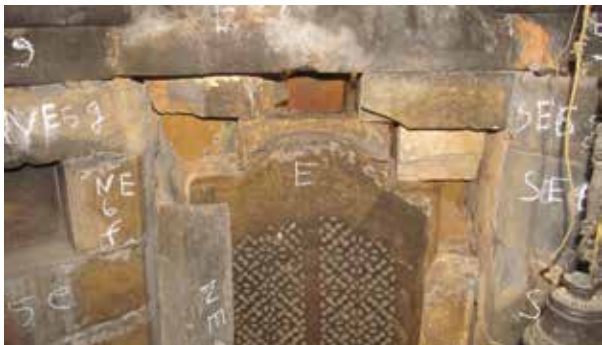
Left & Right Bottom
Inner east face of the *garbha griha* before and after restoration.

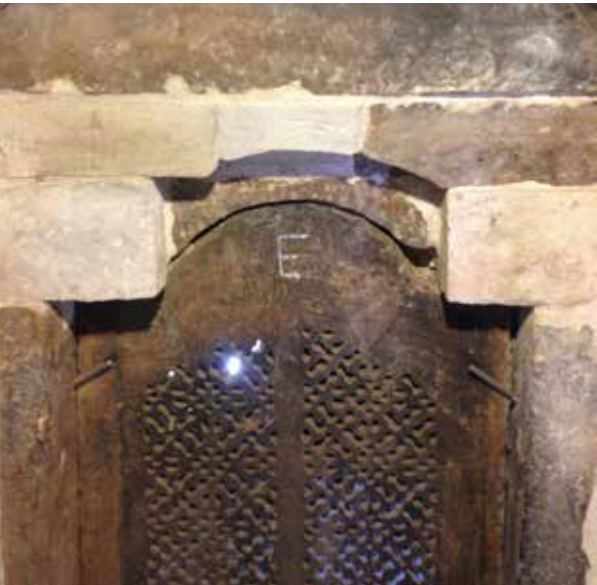
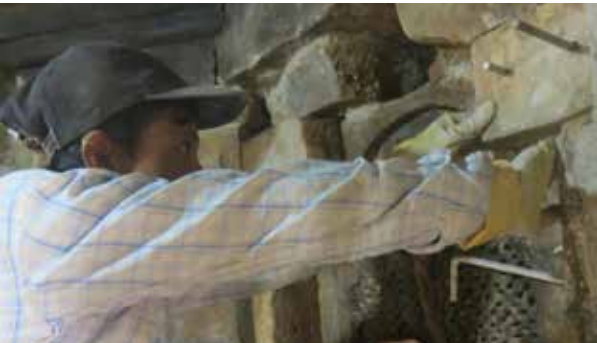
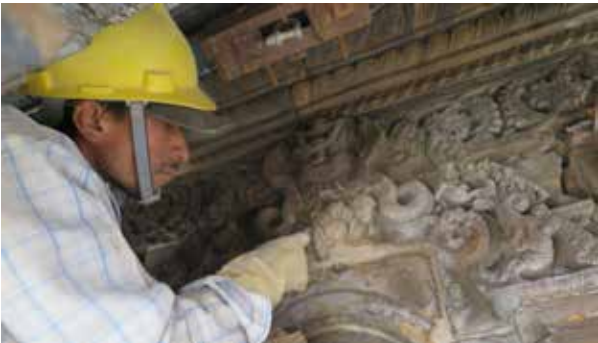
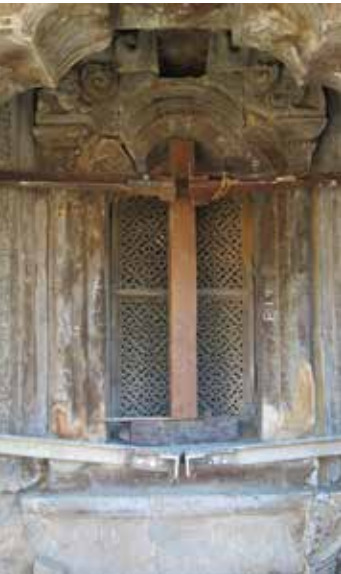
Left Top
Stone mason Surya Bahadur Ranjitkar repairing the dislocated keystone above the eastern portal. (Photo: KVPT. Dec 17, 2017.)

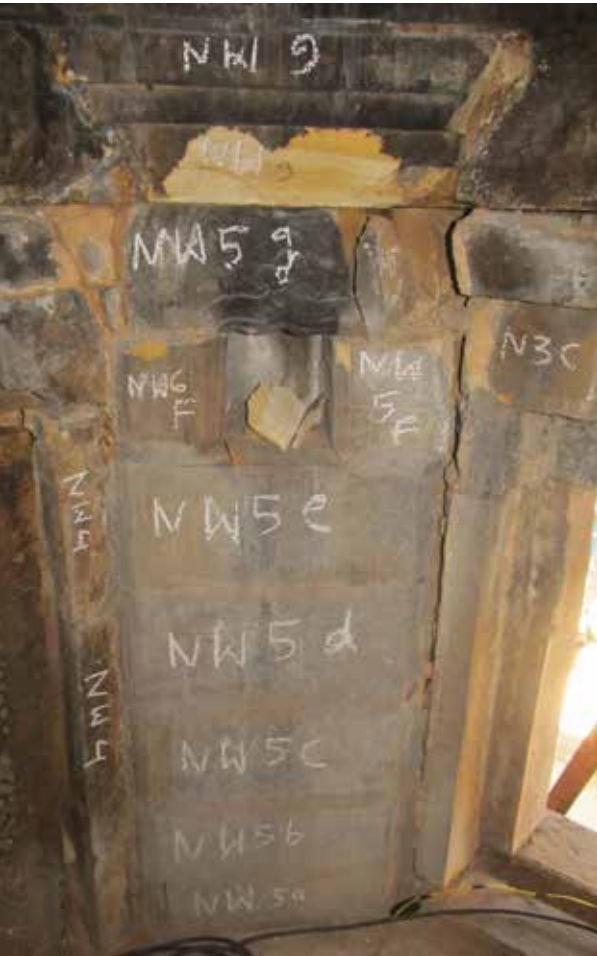
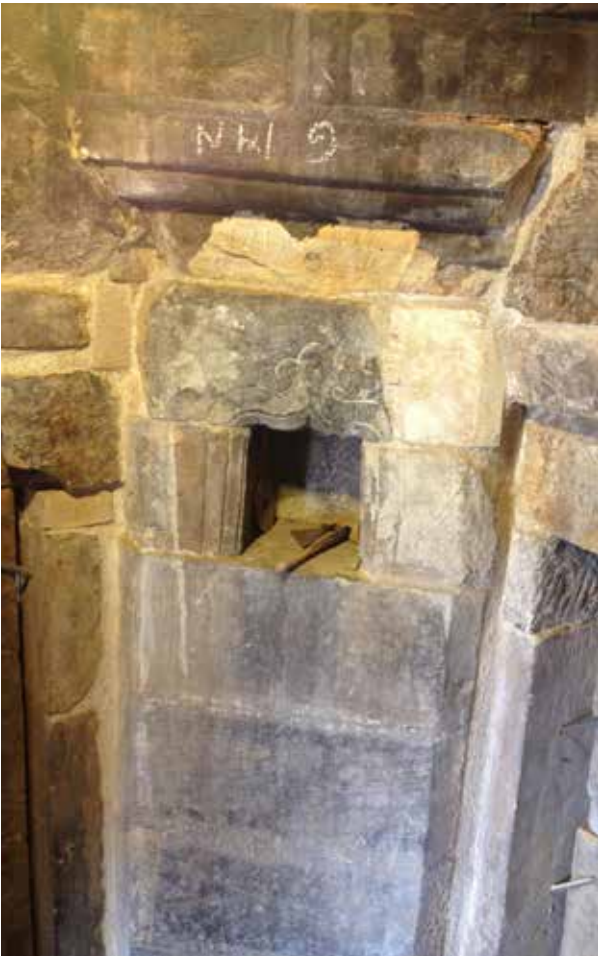
Center Top
Surya Bahadur Ranjitkar repairing the southern portal. (Photo: KVPT. Dec 20, 2017.)

Left & Center Bottom
Inner north west wall of the *garbha griha* before and after restoration. It had to be dismantled completely before restoration.

Right Top
View of the eastern portal before repair. The keystone above the portal had fallen off during 2015 earthquake (Photo: KVPT. Dec 15, 2017.)

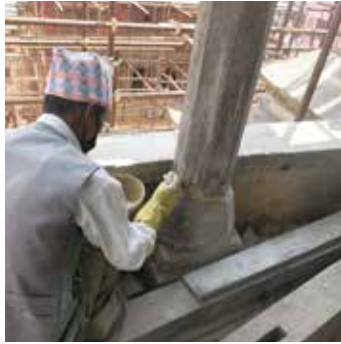
Old pointing repair damage

Due to the lateral movements of the temple during the earthquake, the building stones had been displaced from their position leaving their joints open. The mortar and pointing had fallen off. During the last restoration work done, all the joints were sealed by a grey restoration mortar. Most of this pointing had fallen off. Water ingress in other areas also showed that the joints had opened allowing water to come in. There was a great need for sealing all the joints again.

It was recommended that the old pointing be carefully removed by hand or manual tools in order to avoid

damage to the stone and the depth be sufficient to hold the new mortar. Correct tools be were used for this. After flushing out the open joint with a jet of clean water, damp it down, and filled with compatible lime mortar as advised. If the joint is too big, some fine aggregates could be inserted to reduce cracking on drying. The grain size of aggregate was not to be larger than 1/3d the thickness of the joint. Care was to be taken to avoid any spilling of the mortar on the stone surfaces to prevent staining. Colour, texture, and thickness of the pointing was to match the original pointing. Natural pigments could be used to give the correct colour. Proper curing was to be done after application.

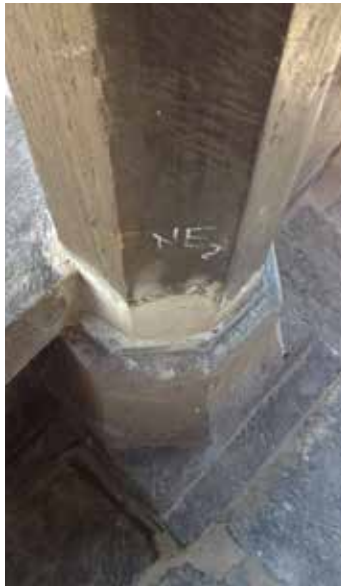
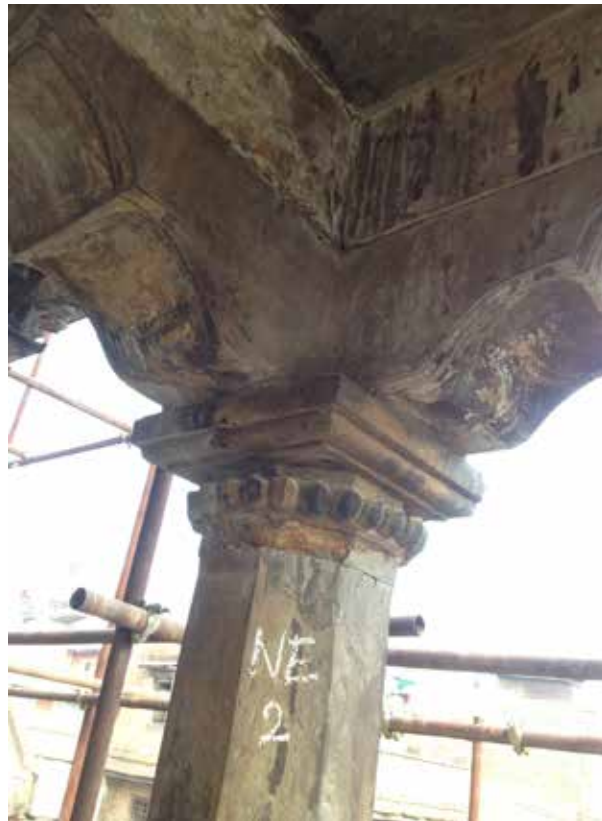
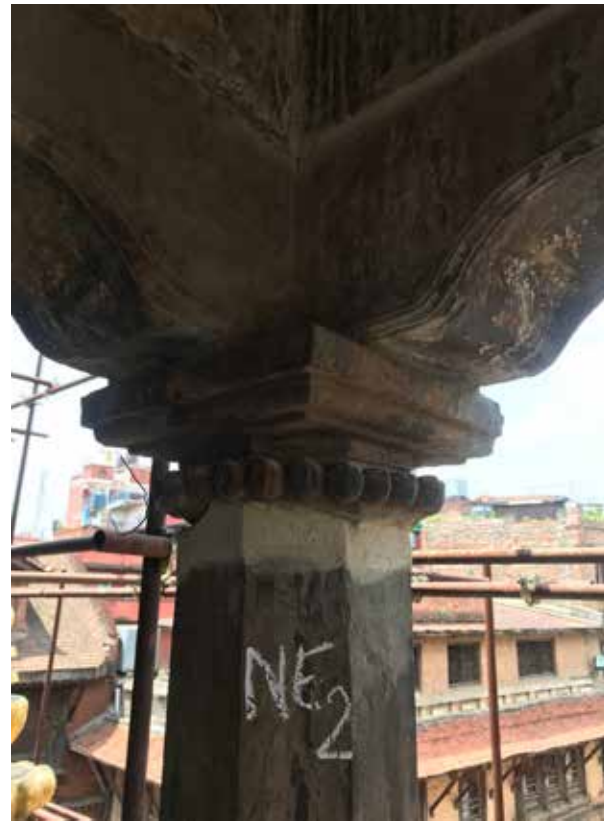
Left Top
Masons Siddhi and Mangal Maharjan pointing column joints after realignment
(Photo: KVPT. May 20, 2018.)

Left Bottom, Center & Right
Much of the old repair was damaged after the earthquake and had to be re-pointed in the column capitals, base, and the other places too.

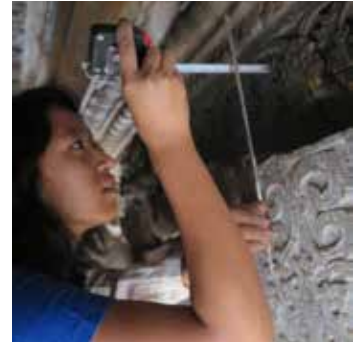
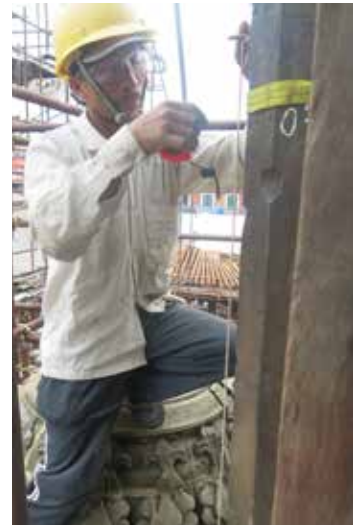
The *garbha griha* is enclosed by two colonnades. The inner colonnade has twelve slender columns and the outer colonnade has twenty slender columns. All columns have a base, shaft, and capital. The beams above are supported on brackets. Due to the lateral movement of the temple during the earthquake, the columns had tilted and were out of plumb . All tilted columns had moved outwards. Seven out of twenty columns on the outer colonnade had tilted, three on the west and four on the south. Columns on the north and east had not

Left & Center
Out of plumb columns before and after re-alignment.

Rigt Top
The column next to northeast corner, on the north side, has moved out of plumb by 3 inches.
(Photo: KVPT. June 20, 2017)

Right Bottom
All outer column from Shiva level being brought to plumb line.
(Photo: KVPT. May 14, 2018.)

It was recommended to first brace the columns to prevent any accident. The columns were then to be straightened with the help of a pulley. Temporary protection like bubble wrap and foam sheets were to be tied around the stone to prevent crushing of edges during this procedure. The stone columns were then to be fixed to the bases and capitals with steel pins, mortar, and adhesive as found necessary. Once this was done, the structural system of the temple would become safe.

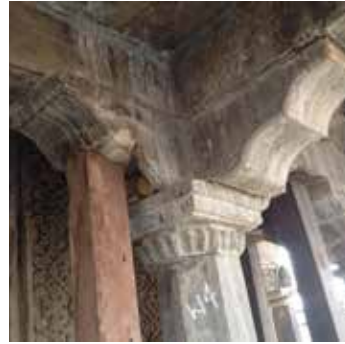
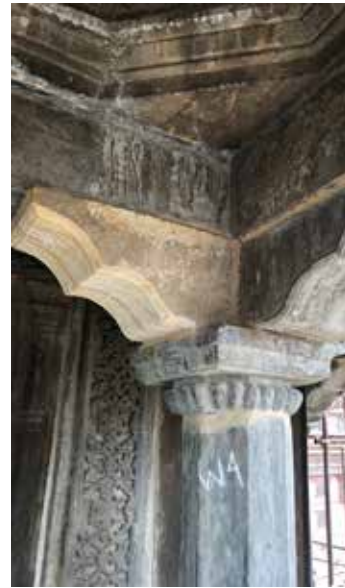
Dislocated and damaged brackets

All beams were supported by brackets made of a single piece of stone. When the columns and the rest of the structure moved, the brackets became loose, as the load above was not sufficient to keep them immobile. These brackets thus twisted in various directions. The maximum movement is on the south west side. (See Plan) Five brackets on the south and west moved away from their position. One bracket in the west was completely broken up and few were partially broken .

Left Top & Bottom
Bracket on the west was re-carved and replaced in position.

Right Top & Bottom
Bracket on the south side re-aligned and restored in place.

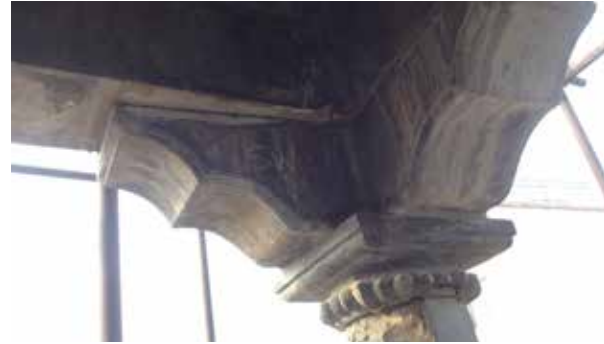
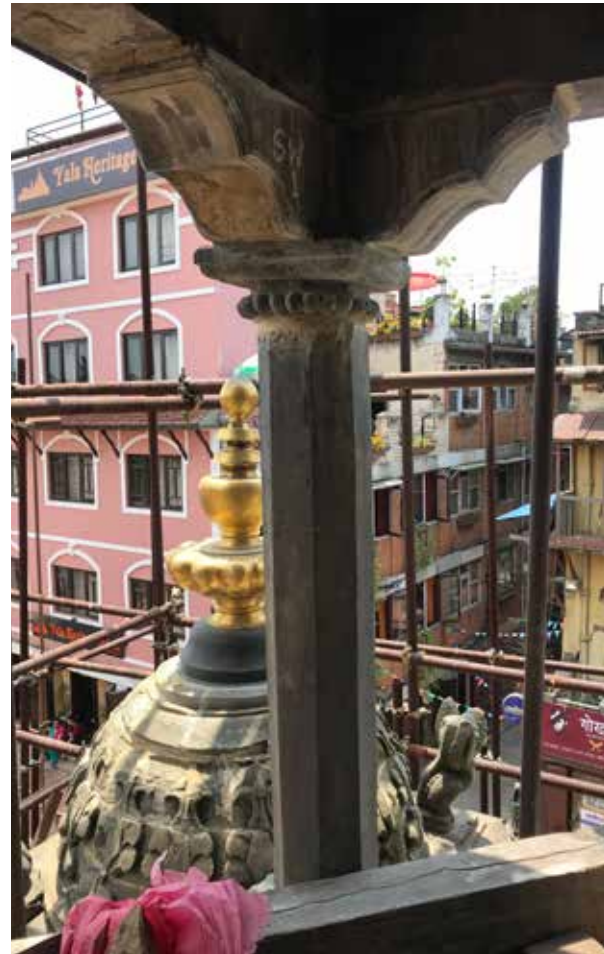
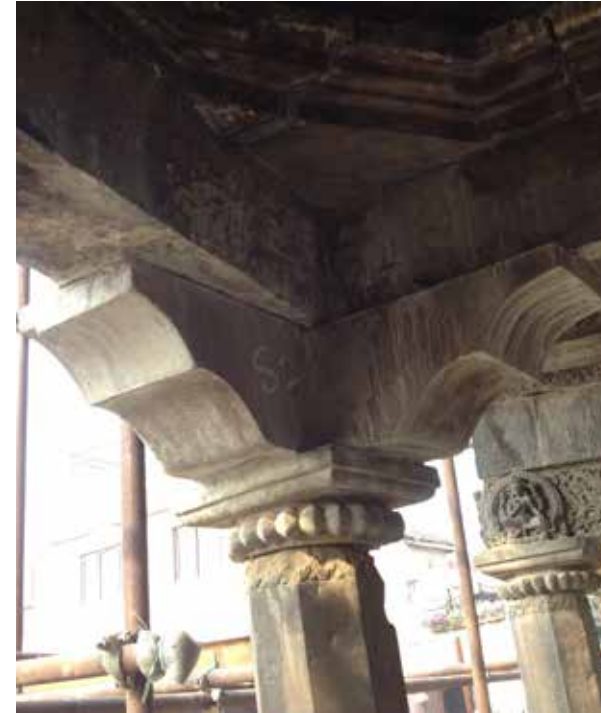
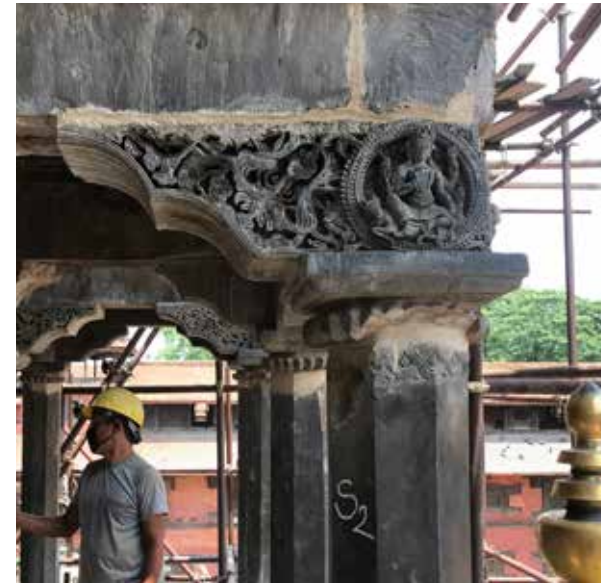
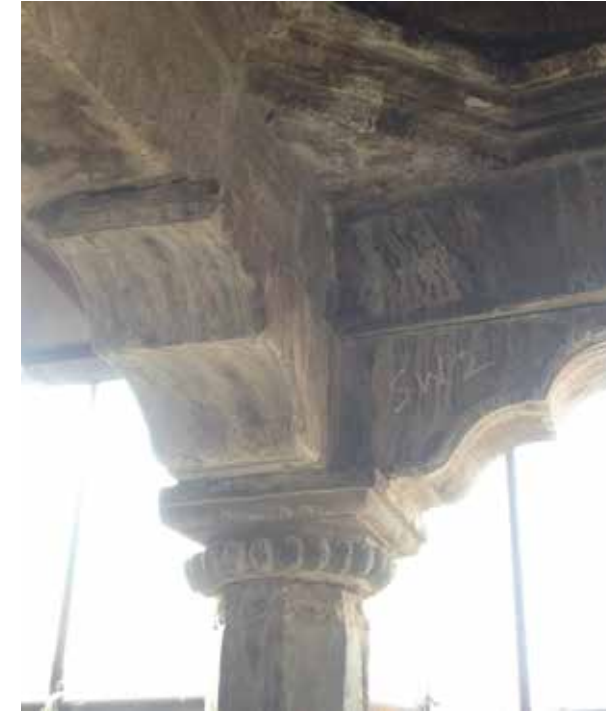
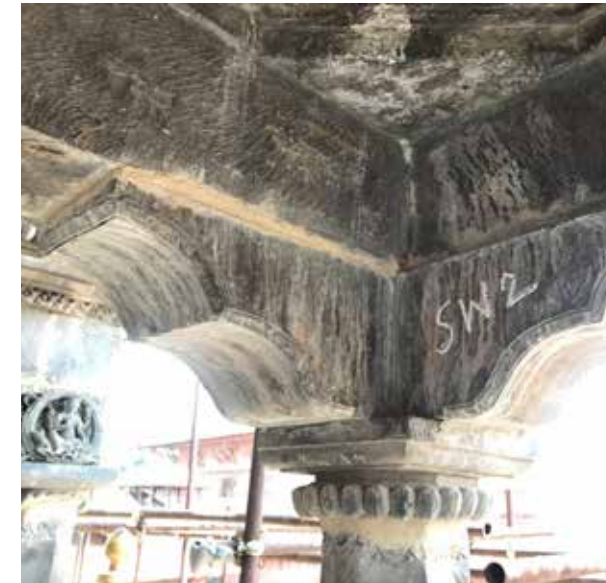
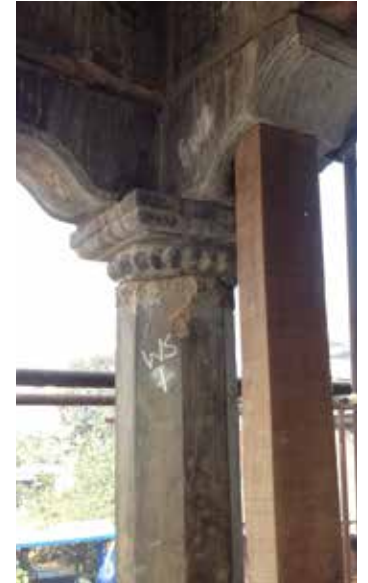
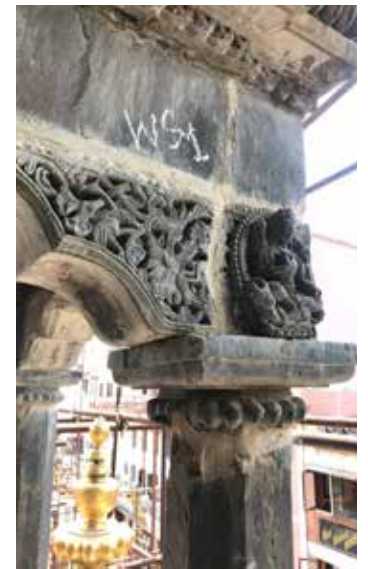
Brackets before and after restoration. Some brackets like S2 could not be re-aligned due to positions of other stone elements.

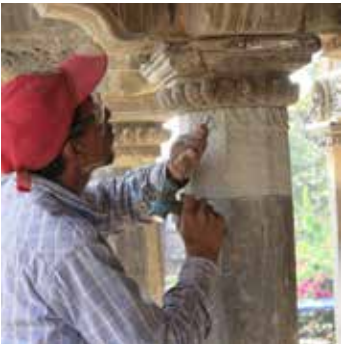
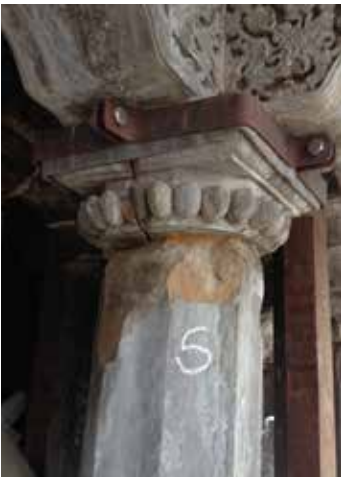
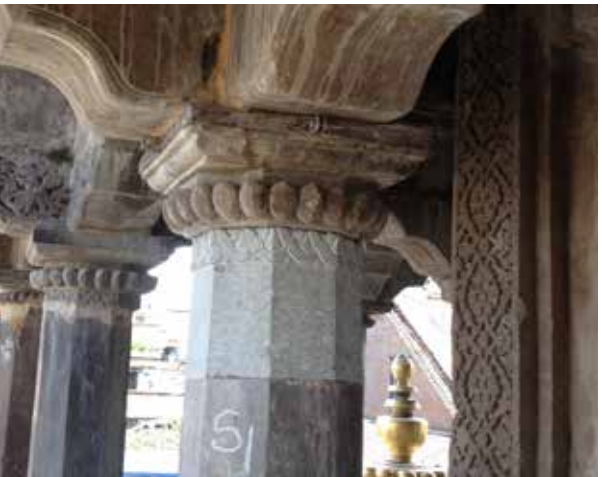
Damaged column capitals and bases

Left
Stonemason adding details to the newly added part of the columns on south at Shiva Level.
(Photo: KVPT. June 20, 2018.)

Left Bottom & Center
Images of capitals before and after restoration.

Right Top & Bottom
Column capital were restored but the steel tie was retained in many cases after restoration as precaution.

The column capitals are composed of a flat stone piece embellished with a floral base. The quality of carving in several capitals indicated old repairs. Due to the seismic loading and movements, some of the capitals were damaged. These damages ranged from severe cracks to minor chipping therefore their repair was also to be fashioned as per the damage. However, it was important that the capitals were stabilized in position by ties and props. A few bases had also been damaged but the damages were not very severe.

It was recommended to first support the beams on both the sides of the column, the damaged capital would have to be replaced in part or whole or repaired after assessment on site. Most of the capitals were carved, but whether the same would be done for the new stones, was a decision that was to be taken later. Fractured capitals would have to be pinned together by using stainless steel threaded bars and epoxy resins. Sometimes pins were not required. At such times patches of structural glue could be used to join the stones. Minor damages could be ignored or repaired with matching mortar.

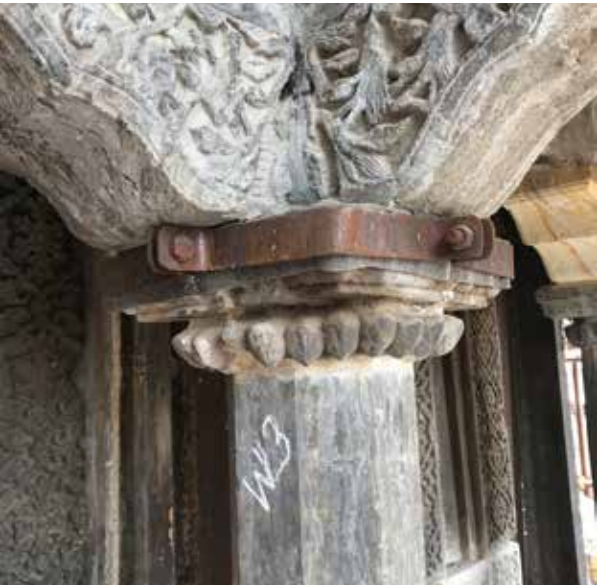
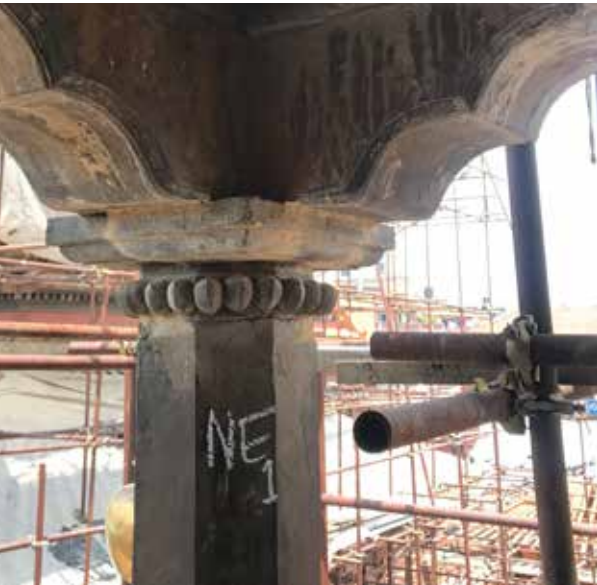
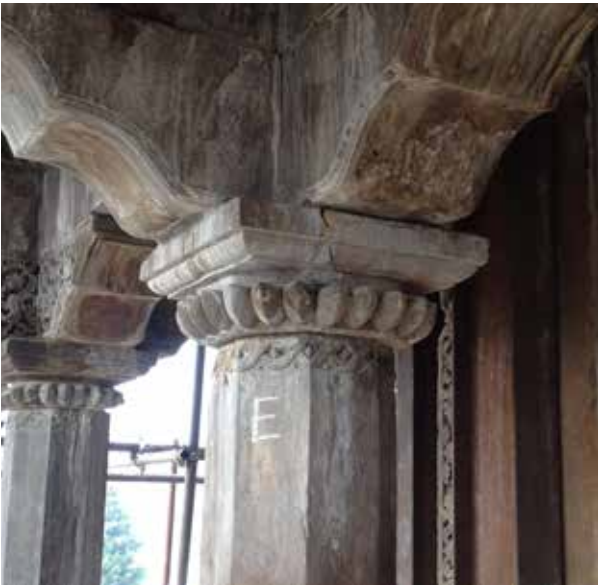
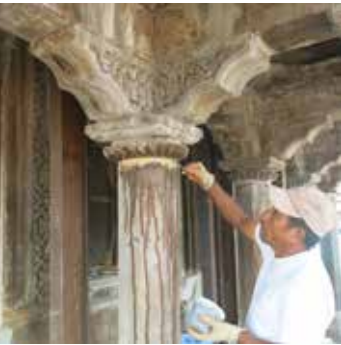
Left Top, Bottom & Center Top, Bottom
Column capitals were restored by pinning, pointing, partial replacement of stone, and where severely damaged or cracked a steel tie was used to hold it together.

Right
Masons Siddhi and Mangal Maharjan pointing column joints after realignment.
(Photo: KVPT. May 20, 2018.)

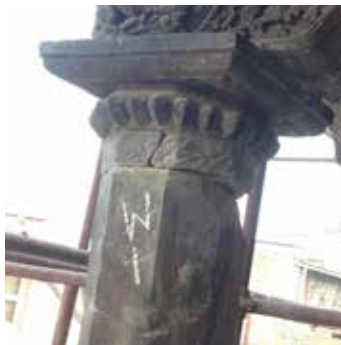
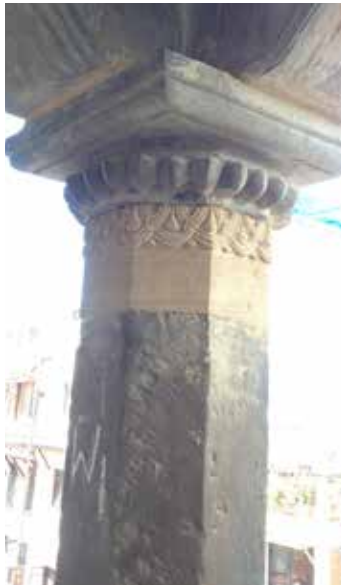
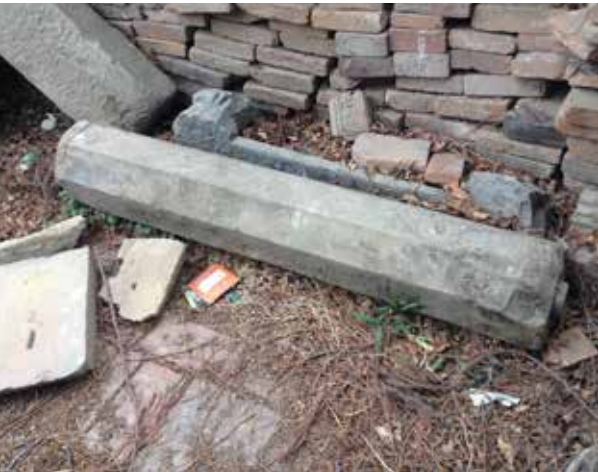
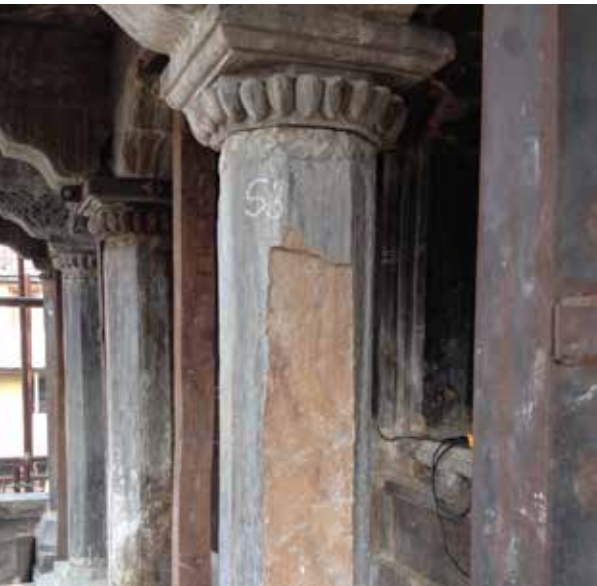
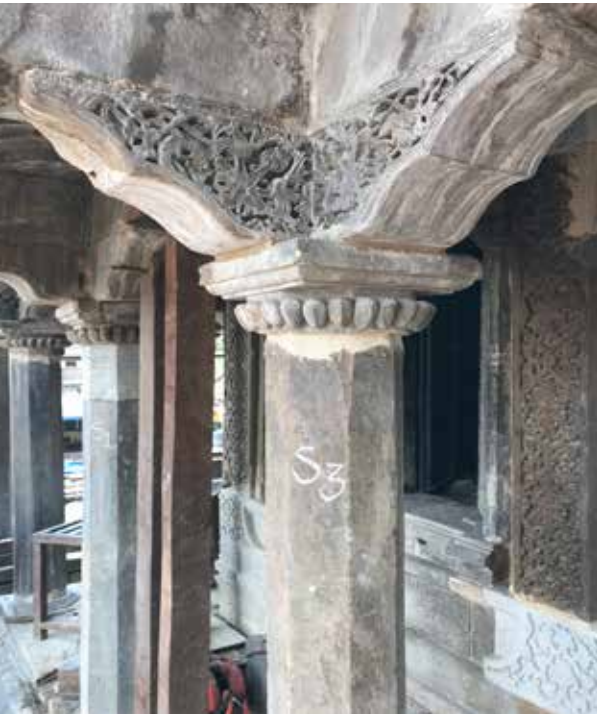
Damaged column shafts

Left Top & Bottom
Top portion of a damages shaft was replaced with a new carved piece of stone.

Center, Right Top & Bottom
The severely damaged shaft S3, had to be replaced. One old column was found in the material yard which was used as a replacement.

Most of the columns were damaged just below the capital. This damage had also happened during the earlier earthquakes because one could see the old pointing repair. Most of this repair came off during the recent earthquake. Although this damage was non-structural, some of the shafts had been damaged beyond repair. One column had been sliced such that one third of the shaft had fallen off. The top of other columns had been severely damaged.

The three damages would have to be dealt with separately. After supporting the beams, the column shaft had to be gently removed. The severely damaged column had to be replaced since it was incapable to carrying load. The others had to be repaired with new stone pieces such that the cross section of the shaft was not reduced. Stone pieces had to be pinned together by using stainless steel threaded bars and epoxy resins. The sliced column had to be replaced . After the repair, the old and new pieces had to perform as one monolithic whole. The minor damages were to be repaired with matching mortar prepared as per specifications provided.

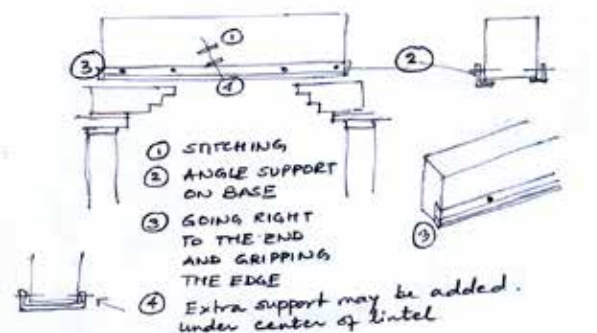
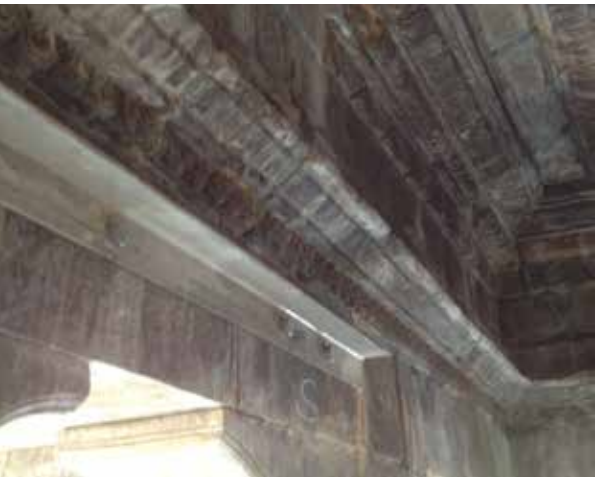
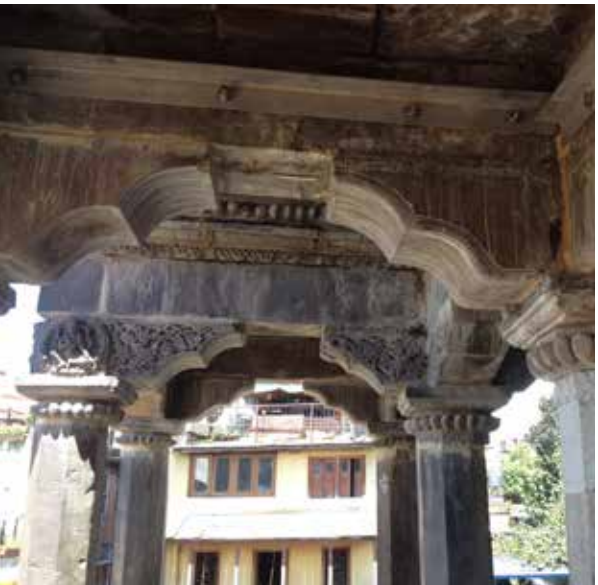
Cracks in lintel

Center Top & Bottom
Vertical cracks in the lintel beams were carefully monitored and tied with stainless steel pins and stainless steel angels using adhesive and bolb.

Right Top
The team of Engineer Pranam Hora, Stone manson Surya Bahadur taking off the column, repairing and reinstalling the outer column of Shiva level west elevation 3rd column from south. (Photo: KVPT. May 10 & 11, 2018.)

Right Middle & Bottom
Engineer Pranam Hora and Stonemason installing the stainless steel angle to the cracked beam. (Photo: KVPT. June 21, 2018.)

It was recommended that the building be carefully assessed for cracks after cleaning. Since the cleaning of the stone surface was only to assess the development of damage or cracks, no chemical or invasive mechanical methods was to be used. Only manual cleaning involving dry brushing with a stiff natural bristle brush (not a wire brush) and (non ionic soap) and clean water was to be used to remove organic growth and surface dirt. The cracks were to be monitored for some time to (using crack gauge or stain guage) assess further movement.

Hairline cracks or cracks upto 5mm were to be dealt by filling the void with matching mortar similar in composition to pointing. Some mastic compound could be used for crack filling to allow a little movement, if it was a thermal crack. Reasons for moderate cracks between 5mm and 25mm was to be assessed for local disturbance of building members like rusted dowels or plant growth. They were to be rectified before filling the crack with compatible mortar. There was one major cracks above 25mm in the lintel which needed the attention of an engineer . Only after an assessment of the overall structural system was this to be rectified. Till then, this was be supported by a steel prop below. Luckily only two cracks in the lintel beams could be identified.

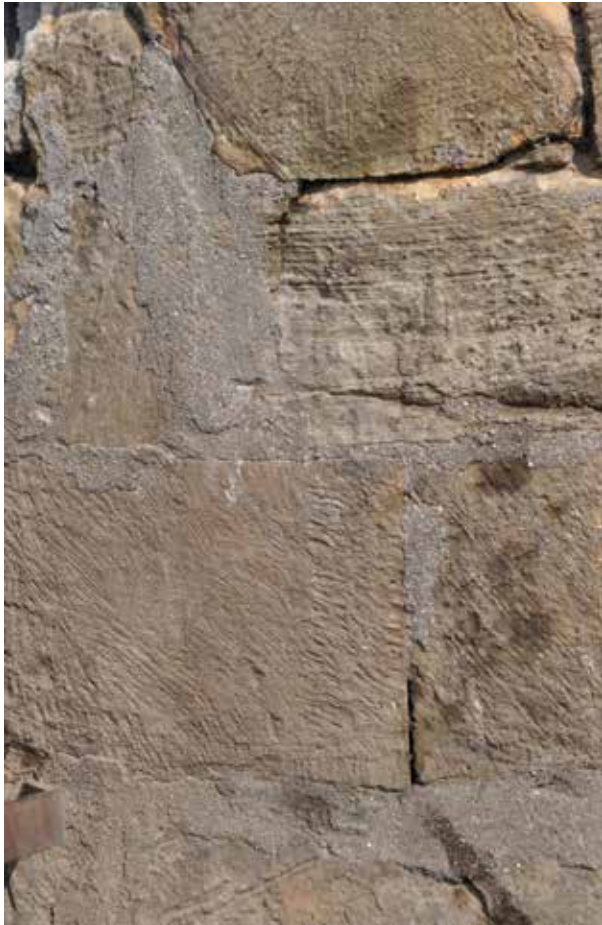
Left
Fig. 1: Mortar Type A.

on the lower floors. Existing joint mortars at the top area were characterized by visual inspections combined with scientific analyses of taken samples using polarizing microscopy and scanning electron microscopy (SEM) in the laboratories of the University of Applied Arts in Vienna⁷. At least four types of mortars could be determined. The first and probably most recently applied one is a very hard greyish cement-based mortar with an adequate amount of aggregates (coarse quartz and alkali feldspar), hereby named type A (fig.1).The used cement is comparable

with Portland cements used in Europe during the interwar period. The mortar was apparently applied not only in most joints but also as a layer above weathered surfaces. Due to its density and capillary-inactivity, the cement mortar allows the stone to remain wet for a longer period which particularly resulted in sanding and disintegration. In some areas the mortar is firmly connected to the stone structure. The second mortar, type B, is not as hard as the above mentioned, but also too dense for the underlying stone. Its colour is greyish but slightly brighter than type A. This mortar has also brick dust as filler.

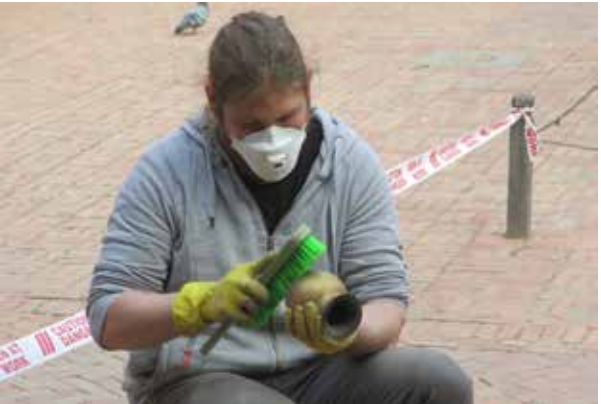
The metal pinnacles distributed over the whole temple are made of fire-gilded copper plates. They consist of multiple pieces similar in shape and size with a height of around 1 m (fig.3), whereby only the top pinnacle

Center
Fig.3: Single pieces of the dismantled metal pinnacle.

Left
Each of the 20 pinnacles were taken apart and were first cleaned with brush to remove loose particles then cleaned using citric acid diluted with water. (Photo: KVPT. Feb 18, 2018.)

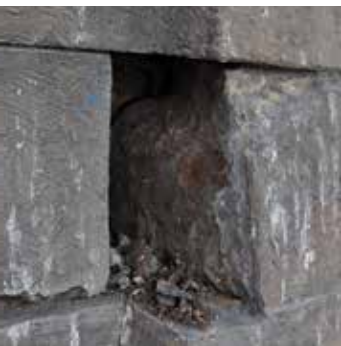
Right Top
Fig.9: Missing stone block, condition before conservation.

Several original stone blocks were in rather bad condition showing cracks, fractures, delamination and detached scales. With regard to the risk, that they may fall down and the unknown date of re-access to the roof area in the future, it was decided to replace these heavily damaged blocks in order to avoid harm to humans by falling parts (see mappings 2-5). The local stone mason was assigned to prepare tight-fitting stone indents (figs.13 and 14). These were just fixed with a few spots of epoxy resin (Akepox 2010, Akemi), further reinforcement (e.g. pins, clamps) was not considered necessary to keep them in place (fig.15). After hardening of the resin, the joints around the new stone blocks were repointed.

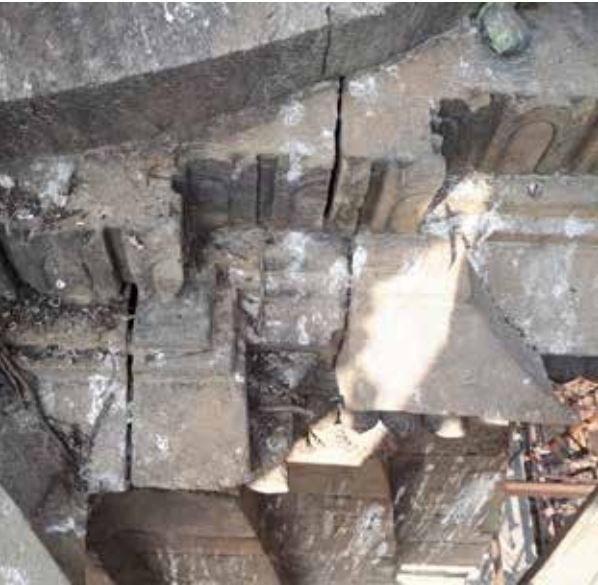
Right Top
Fig.7: Cracked stone, condition before conservation.

Right Bottom
Fig.8: Sanding and scaling of stone, condition before conservation.

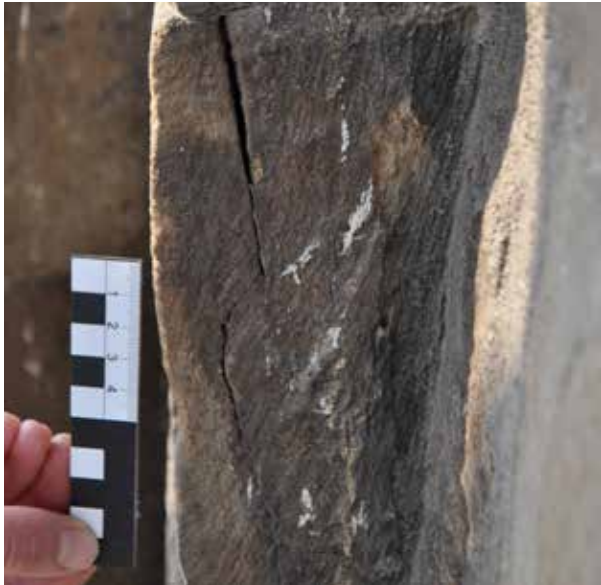
At the time of the survey all surfaces were covered with partly loose deposits of dust and dirt as well as pigeons droppings (fig.5). Several joints were open and still available mortar was partly cracked at the flanks to the surrounding stone or internally (fig.6). Both enabled water infiltration. The extensively applied cement-based joint mortars (type A and type B) were not suitable for the surrounding stone (too dense and stiff) and resulted in accelerated deterioration of the stone material, like sanding and scaling (figs.7 and 8). Moreover the mortar was partly applied as thin layer over the stone surface, which not only altered the shape of the surface but caused waterlogging in the stone underneath and disintegration and sanding. Corroded iron clamps inside the structure caused cracks in the stone. Even some missing stone blocks could be detected (fig.9). In the open joints and gaps accumulated dirt provided a sound base for plant growth.

Left
Fig.6: Old joint mortar, partly cracked or missing, condition before conservation.

Damaged or inadequate joint mortars were removed mechanically with hammer and chisel to a depth at least twice the joint width (figs. 11 and 12). Further, thin layers of mortar, which were applied over the stone surfaces were reduced carefully.

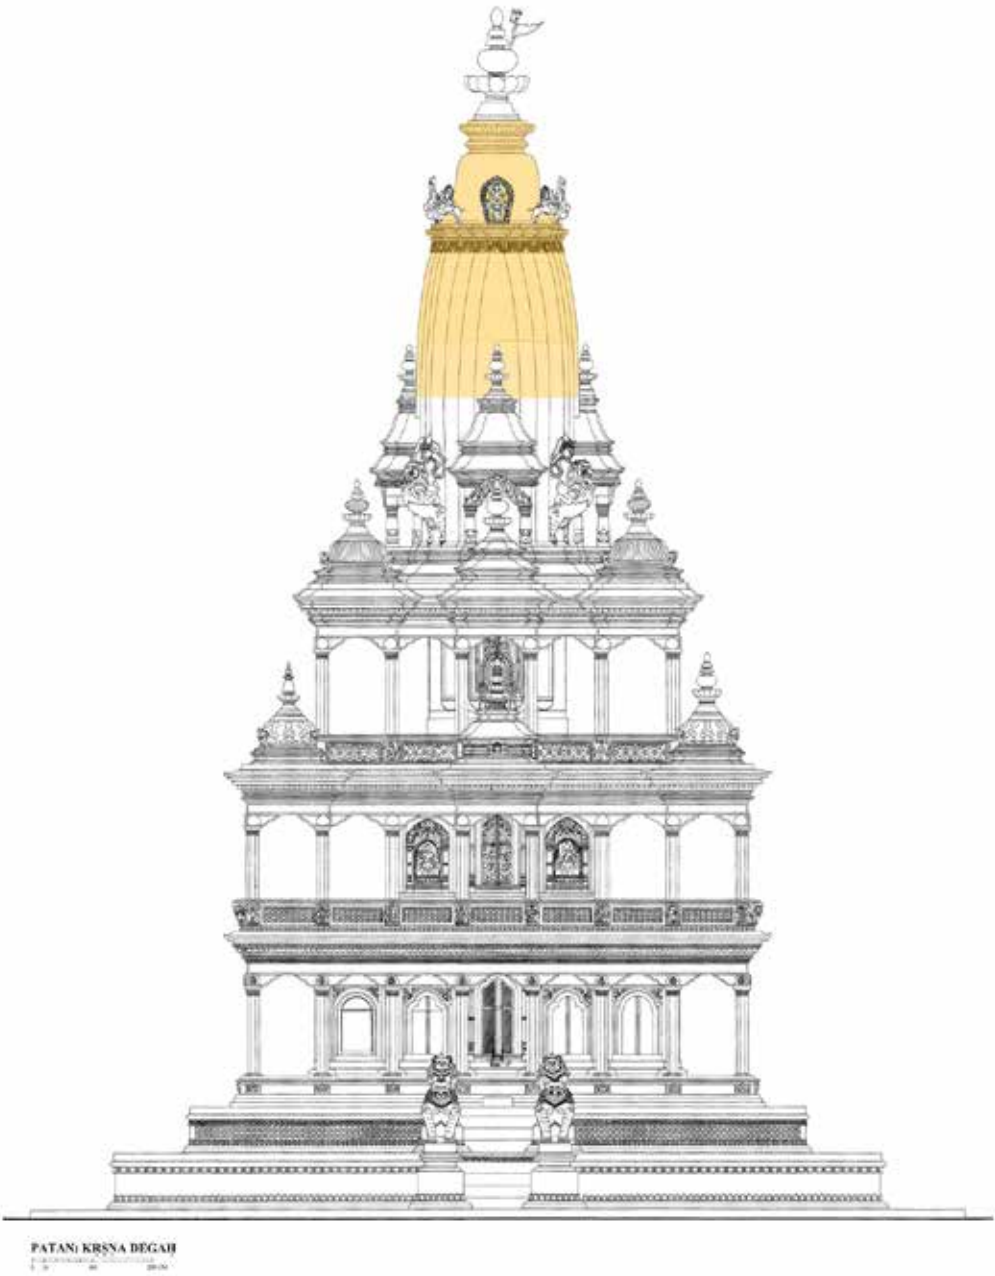
Mapping 1: Front elevation of the Krishna Mandir, treated roof area is marked in yellow, (State February 2018) drawing by KVPT, modified by Katharina Fuchs.

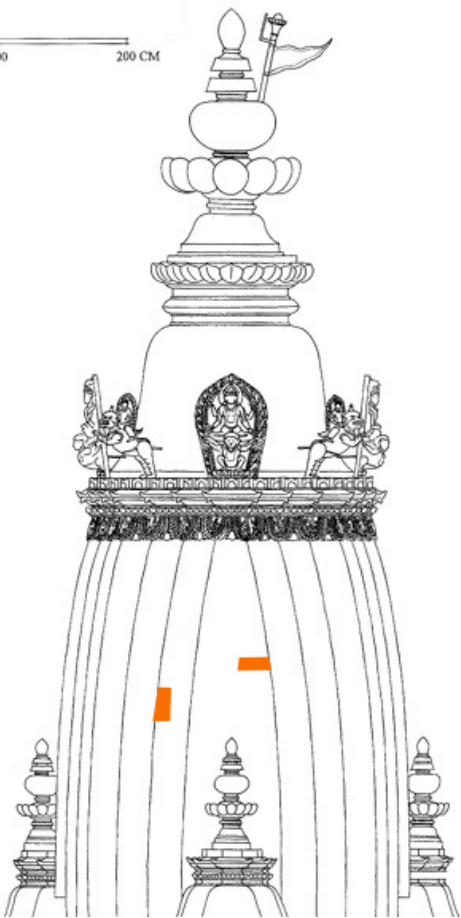
Mapping 2: North -mapping of new stone blocks, drawings by KVPT, modified by Katharina Fuchs.
